28TH MARCH 2008

The objective of this Audit is to compare the building's current actual performance to both the first year performance and the original design intent. Identify any performance gaps, and provide recommendations to rectify these.

The scope of this project includes the collection and analysis of all available data relevant to the Szencorp building performance for the various systems outlined in table 1.1 below. This involves a comparison between baseline data, first year data and current performance of all these components. This report also outlines specific solutions recommended for implementation to improve both energy and water efficiency.

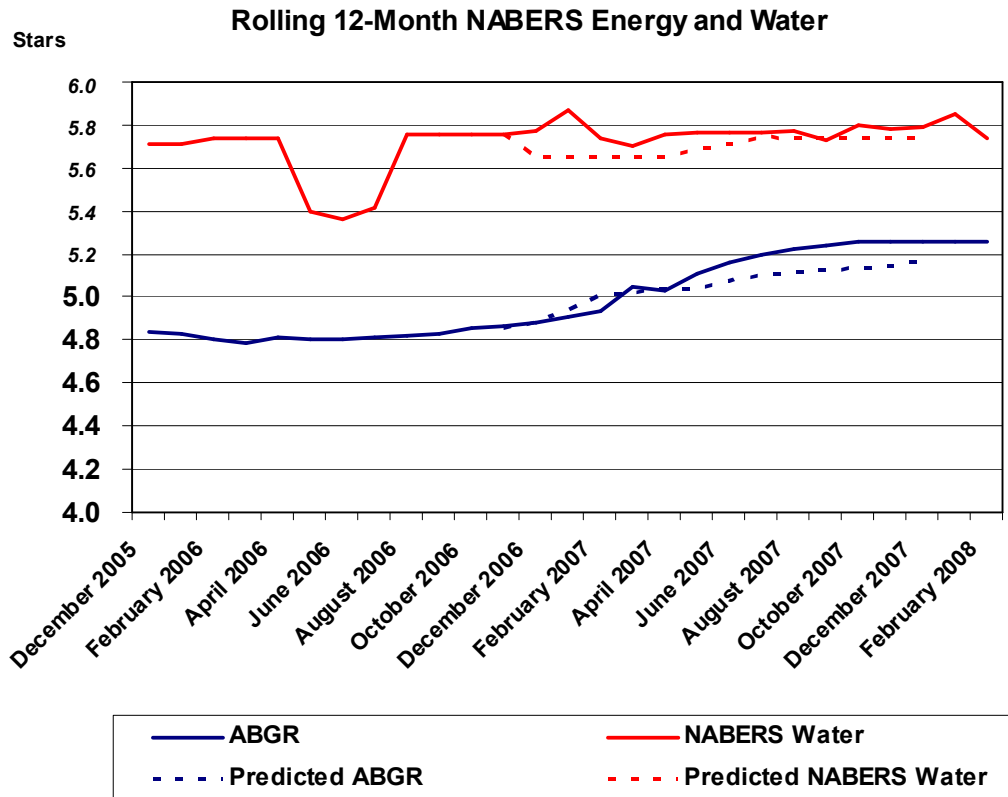
Graph E.1: Rolling 12 month ABGR and NABERS Water

Dotted lines represent the expected ABGR and NABERS Water as predicted in the first year building report, while the solid lines indicate the actual results achieved during the second year operation of the building. Once again for clarity, the data used to build this graph is unofficial.

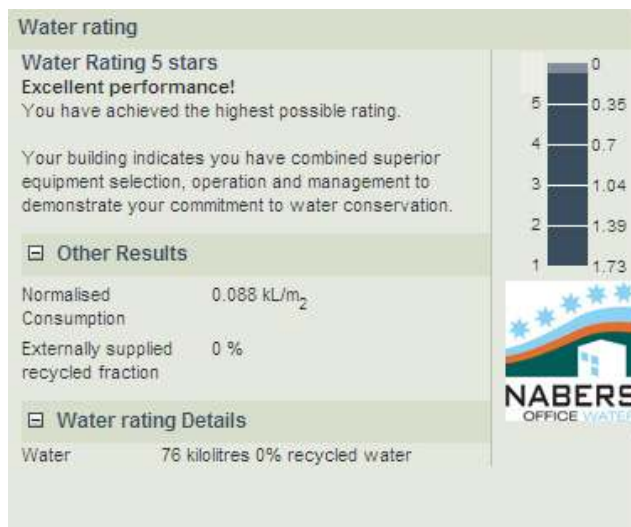
Image 1.2: NABERS Water Calculator Output

Water consumption through the second year of building operation has fallen below the predicted figures, however this is primarily due to reducing occupancy. The normalised water consumption as indicated in image 1.2 above is marginally better than the building's 0.09 kL/m² design intent at 0.088 kL/m² per annum.

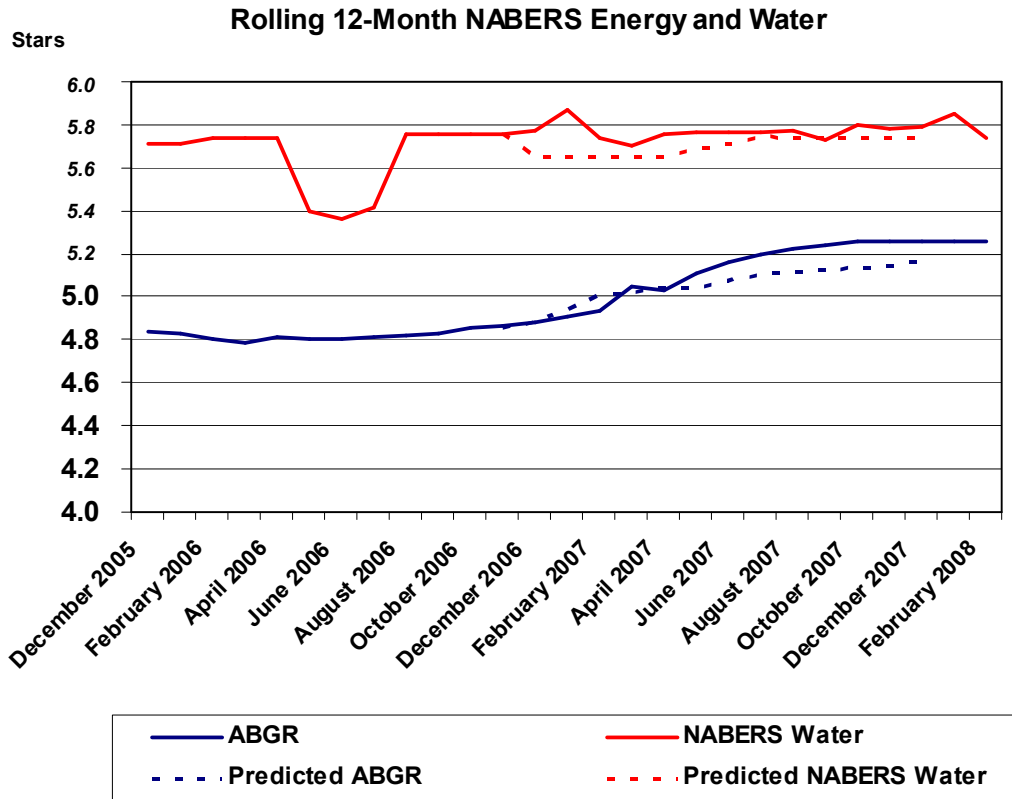
Graph 1.1: Rolling 12 Months NABERS Energy and Water

In graph 1.1 the dotted lines represent the expected ABGR and NABERS Water as predicted in the first year building report, while the solid lines indicate the actual results achieved during the second year operation of the building. The improvement in building performance has been achieved through a number of measures, some identified within the first year building report and others identified and implemented throughout the second year. Full details of the measures taken to produce performance improvements are given within the corresponding sections of this report.

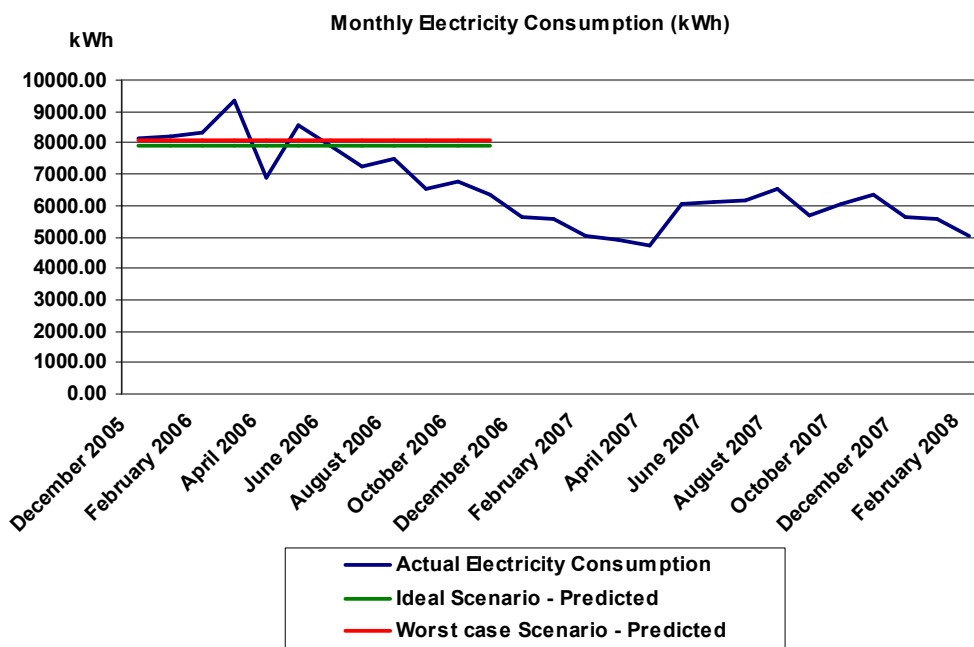
Graph 1.2: Building monthly electricity consumption

Graph 1.2 tracks the electricity consumption performance of the building from inception through to current day, the trend indicates a minor seasonal load with dipping consumption towards the end of summer where temperate weather allows for significant periods of free cooling during the day and night purge in the evening. During these periods the pumped cooling / heating circuits are off and the gas heat pump residual electrical and controls loads are low.

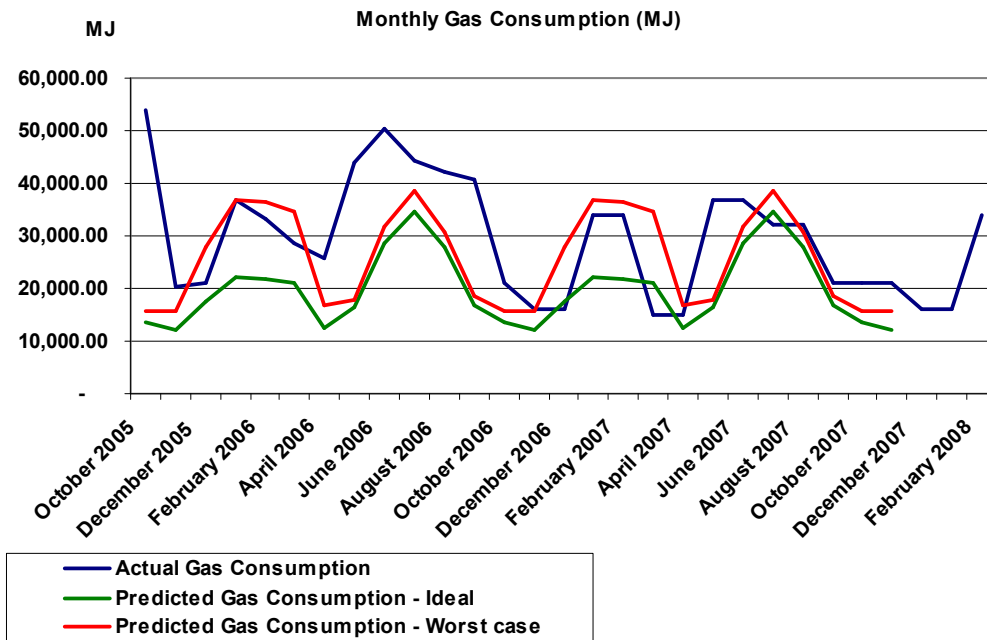
Graph 1.3: Building monthly gas consumption

Second year performance results better than the design intent for the building have been achieved through our commitment to ongoing improvements to the building services. There are further modifications recommended to improve the performance of the solar hot water heating, which would yield improved figures again for the third year building report to come.

The higher than expected gas consumption in October and November 2005 was attributed to the un-commissioned heat pump system running on full load for long hours. Final commissioning in November 2005 saw this consumption reduce to below predicted levels between December and March. The variance since commissioning was the subject of investigation into;

One of the First Year Building Report recommendations was to install metering on each of the gas appliances as previous to January 2007 there was not data available to identify the cause of higher consumption. Through the installation of metering it has been established that both the DHW and the Gas Heat Pumps are operating near design levels. The fuel cell had been consuming gas at a higher than predicted level. There have been a number of fine tuning alterations to the HVAC system which have produced further savings and it can be seen from Graph 1.3 that gas consumption is tracking close to the design intention.

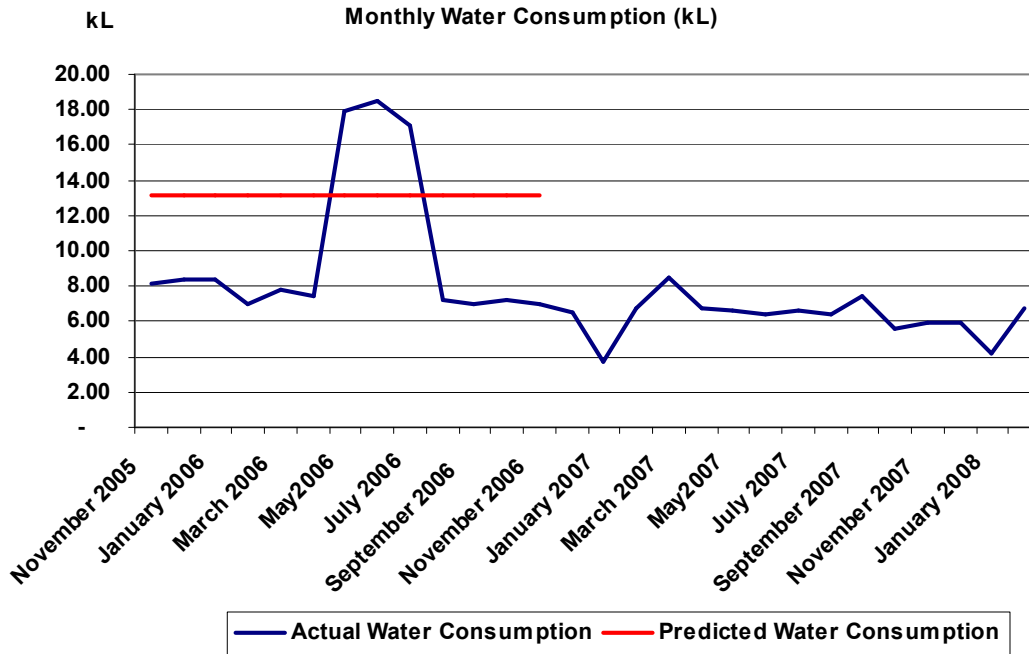
Graph 1.4: Building monthly water consumption

Graph 1.4 below shows the mains water consumption between November 2005 and January 2008. As identified in the First Year Building Report there was a water leak in mid 2006, resulting in increased consumption by approximately 30kL. Subsequent data indicates that the building maintains a stable consumption at approximately 7kL per month with a slight trend downward. This downward trend may simply be a result of decreasing occupancy figures across the year.

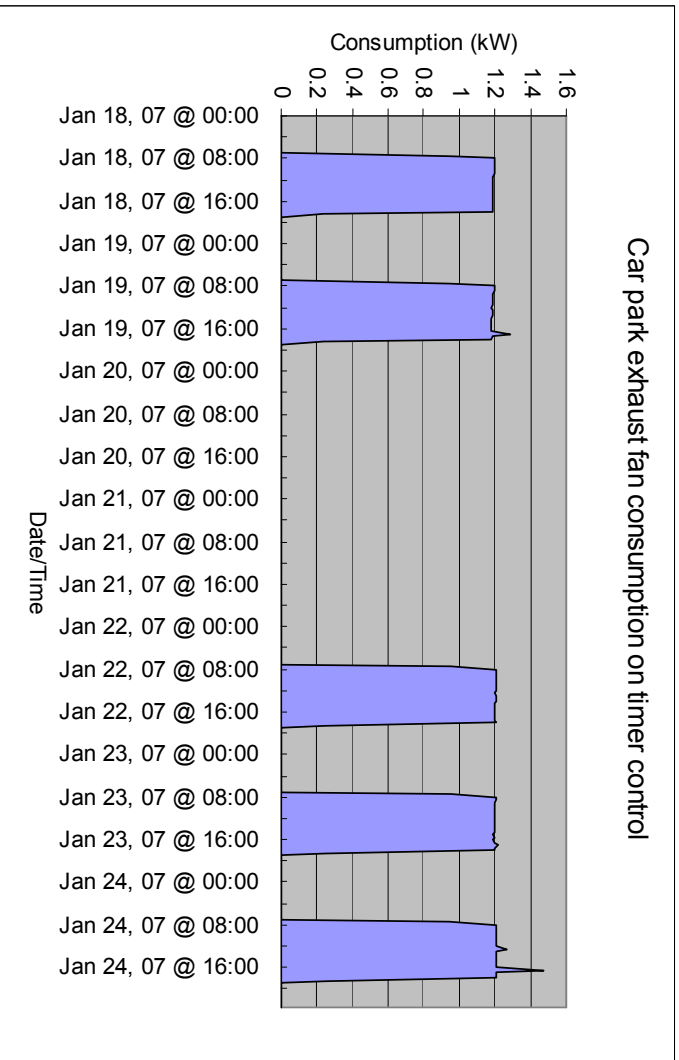
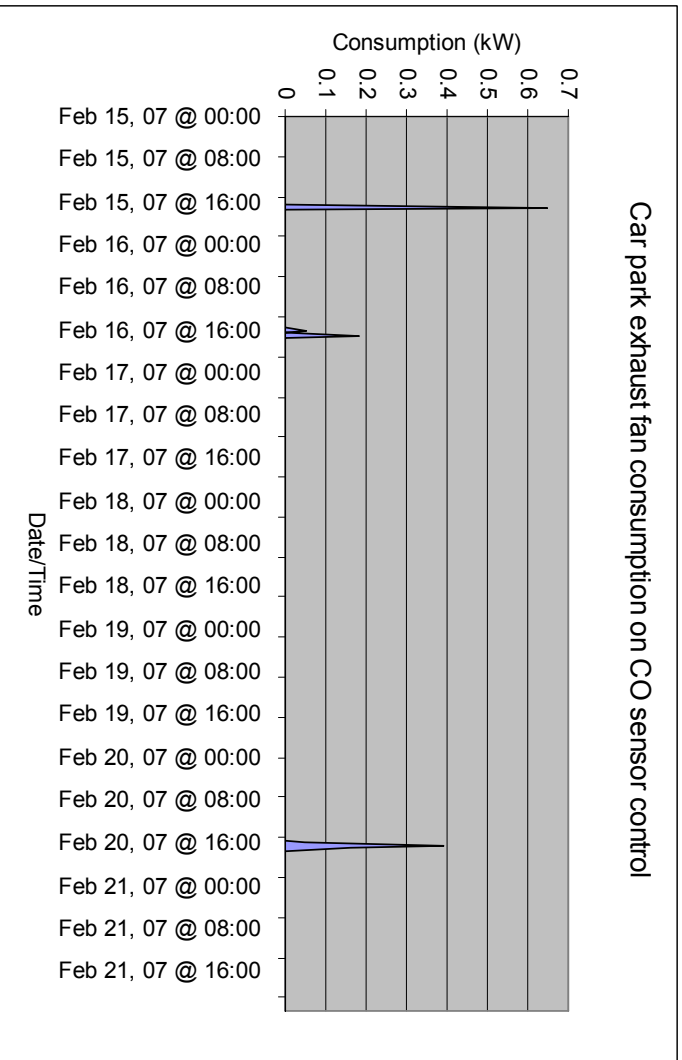
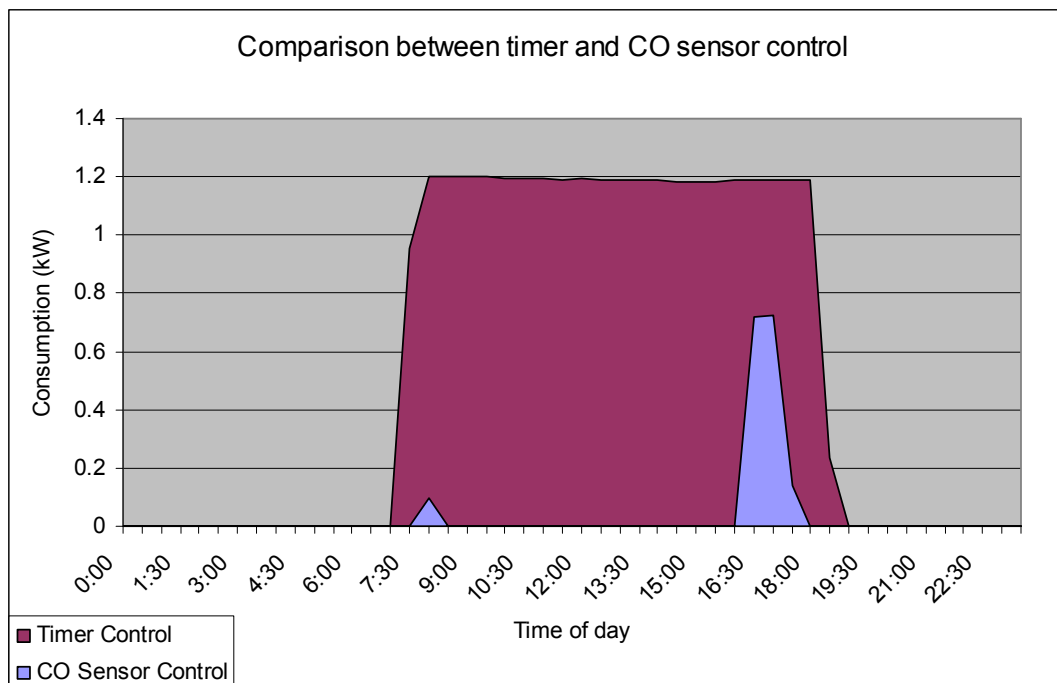
Graph 2.3: Daily load profile comparison between timer and CO sensor control

Based on Timer control, the consumption of power for the car park exhaust fan remains constant at approximately 26.2 kWh per day for each business day of the year. Based on 50 weeks this yields an annual consumption of 6,625 kWh.

The actual consumption identified after the completion of installation works for the CO sensor are better than predicted, with an average consumption of 2.98 kWh per day. This figure changes daily according to the number duration and frequency of CO detection events. The data indicates the actual savings in electrical consumption based on this energy control measure is 6,029 kWh, a reduction of 91%. (7th March 2007 to 6th March 2008 total consumption against this meter was 596 kWh)

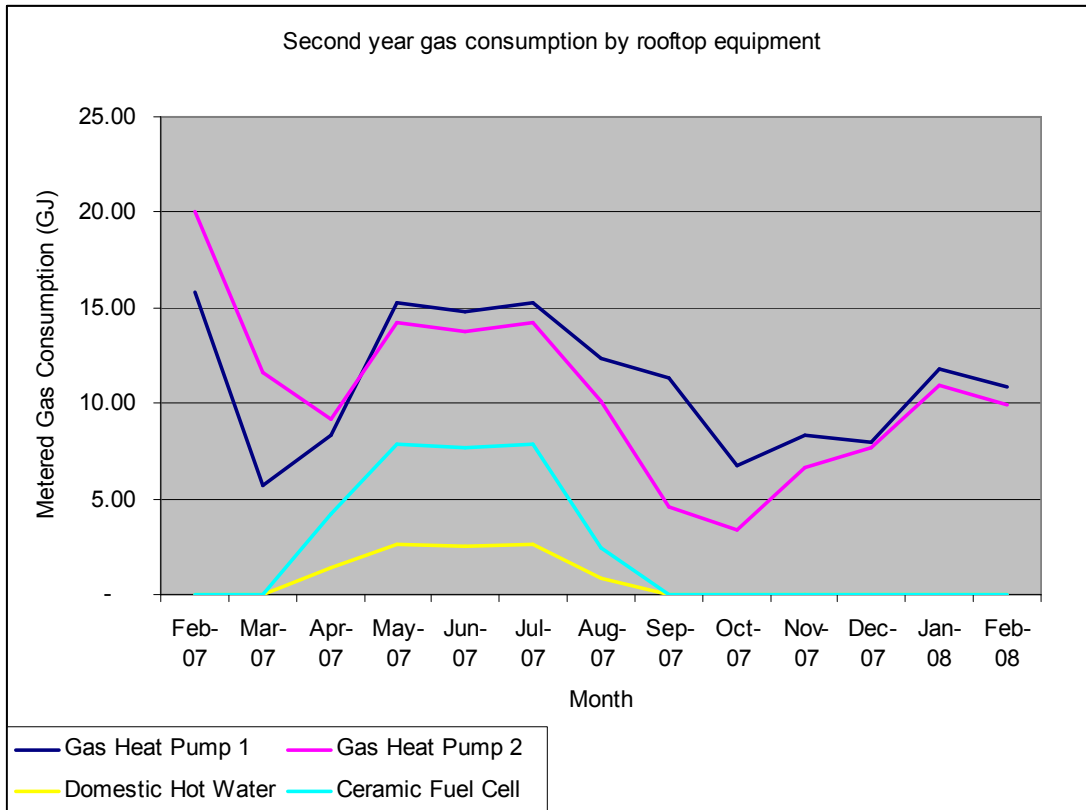
Graph 2.4 Second year gas consumption by rooftop equipment

Of the total billed gas consumption for the building, DHW production shows a gas consumption of 10.11 GJ and monthly analysis shows consumption only in winter months when the solar water heating is less effective or unavailable.

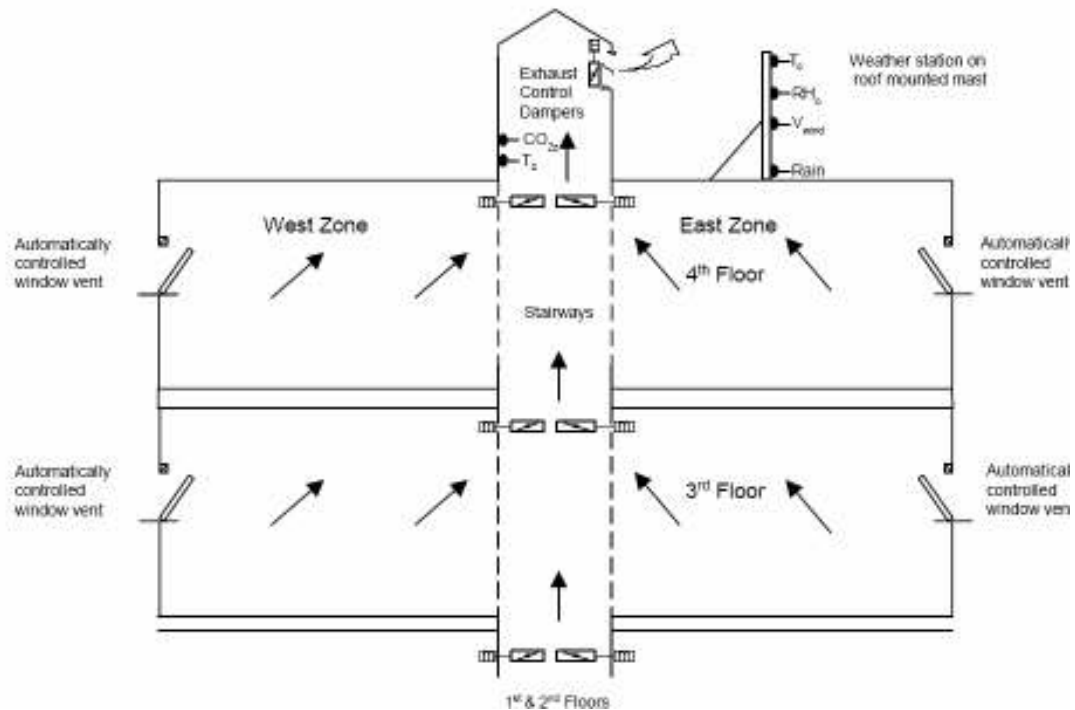
Figure 3.4: Natural Ventilation at 40 Albert Road

A number of programming errors were identified with the natural ventilation operation, in particular with the linking of exhaust ventilation and FCU operation, which resulted in the plant operating at raised consumption levels and the conditioned air was being lost through the exhaust dampers. The various modifications to the BMS system as detailed in section 3.3 has rectified these issues.

There continues to be some concern over the accuracy of the weather station rain and wind speed sensor. These items were calibrated and recommissioned in line with recommendations in the First Year Building Report, however, they appear still to be failing on occasion. This has led to the recommendation this year to install dedicated equipment for the sole performance of rain detection and perhaps also wind speed.

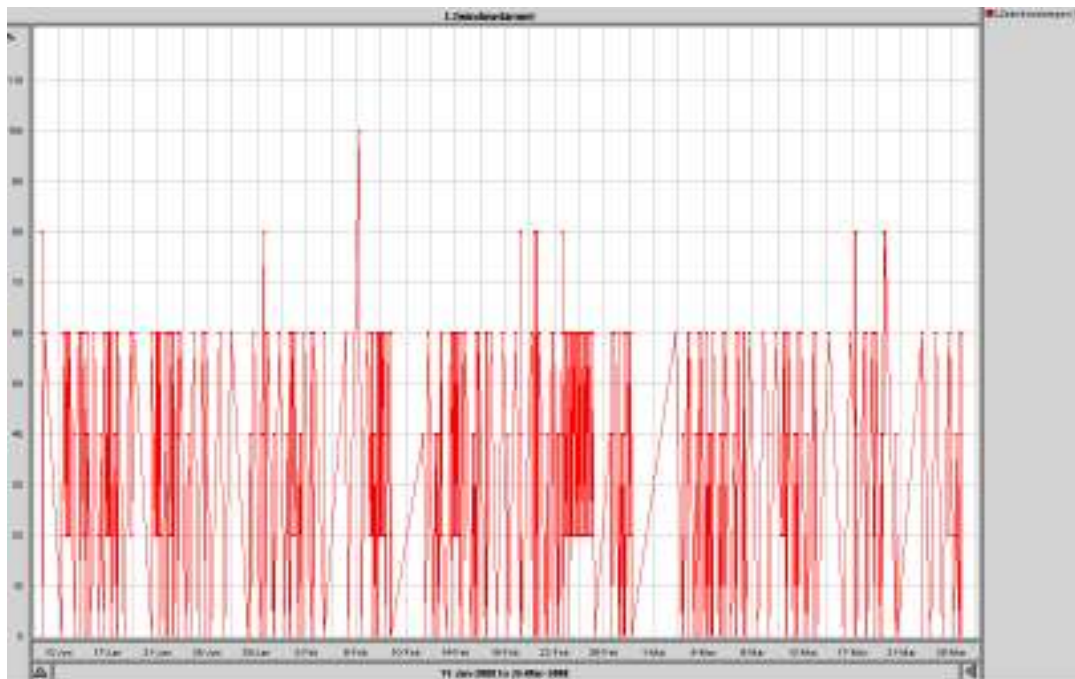
Figure 3.5: Night cooling window damper positioning

Night cooling is operating almost daily in recent months and generally across the warmer months of the year. Figure 3.5 indicates the window damper positioning for level 2 windows over the past three months with a high level of free night cooling. The figure displays damper position in red operating at various damper positions although predominantly open 80%. On occasion when the night time temperature is high, the BMS ensures window dampers remain closed. There are a number of days within the data which indicate this was the case, particularly at the beginning of March.

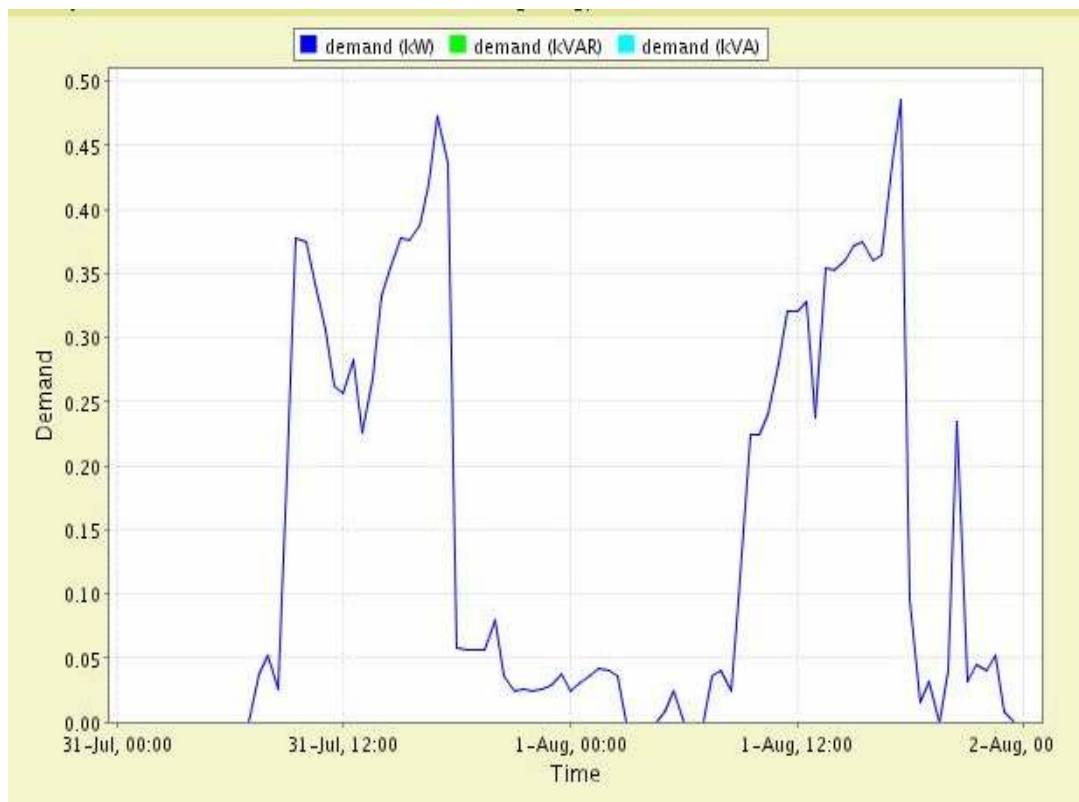
Figure 4.1: Level three office lighting demand July 31st and Aug 1st 2007

Photocell regulation provides considerable dimming of occupied zones on the east side of the building in the morning and on the west in the afternoon. Dimming during sunny periods is to a level as low as 3%, while maximum levels across the building (during times of little ingress natural light) are around 85% of full lamp output. The maintained light levels were set at night-time during commissioning of the building to ensure that the maximum levels were not exceeding the required lux levels. As lamp output depreciates, it is expected that this 85% maximum level will increase in order to maintain these required levels. This may increase energy consumption very slightly.

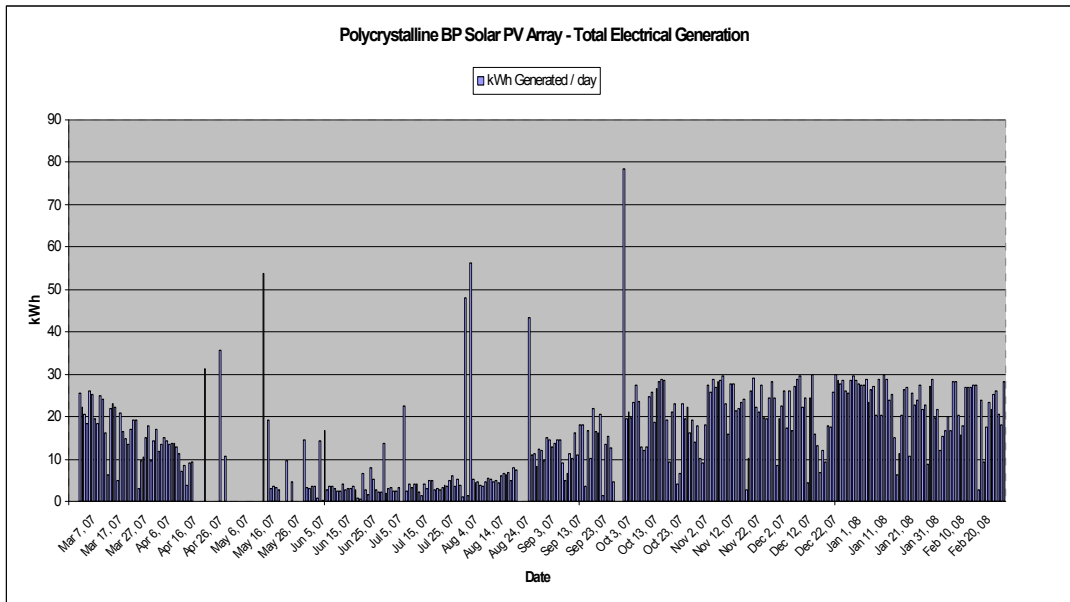
Graph 5.1: Polycrystalline PV Electrical Energy Generation

As can be seen from figure 5.1 above, the winter performance of this array is very poor. Average electrical output for this array during the winter months (June, July, August) is under 6 kWh per day. The major factor affecting the output performance of this PV system, is the fact that there is a large amount of shading of the

panels present during the winter period due to the sun's much lower angle in the sky. This issue, as well as recommendations to alleviate the problem, are explained in further detail in the first year building report text.

5. On site Generation	5.6.1	Modify system to improve current poor performance of rooftop PV array due to shading	\$5000	\$265	2.9	18.8	This issue has be raised again for the second year building report however original recommendation information may also be found in the relevant section of the first year building report in Appendix A

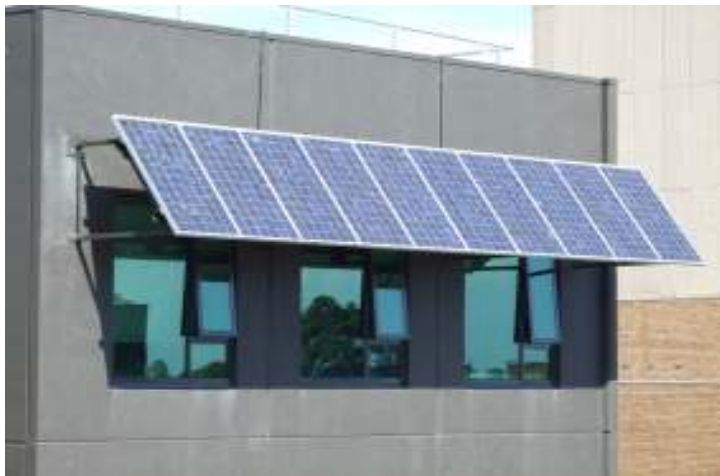
Image 5.2: Polycrystalline PV Solar Shades – Western End

As can be seen from figure 5.2, this array serves the dual purpose of on-site electricity generation, as well as providing shading to the west facing level 4 windows. This photo was taken on the 11th March 2008 at approximately 4:00pm, and shows that the shading aspect of this array is operating well. During the time of

day when the full western sun would normally be striking the windows, it can be seen that the entire windows are in complete shade as intended.

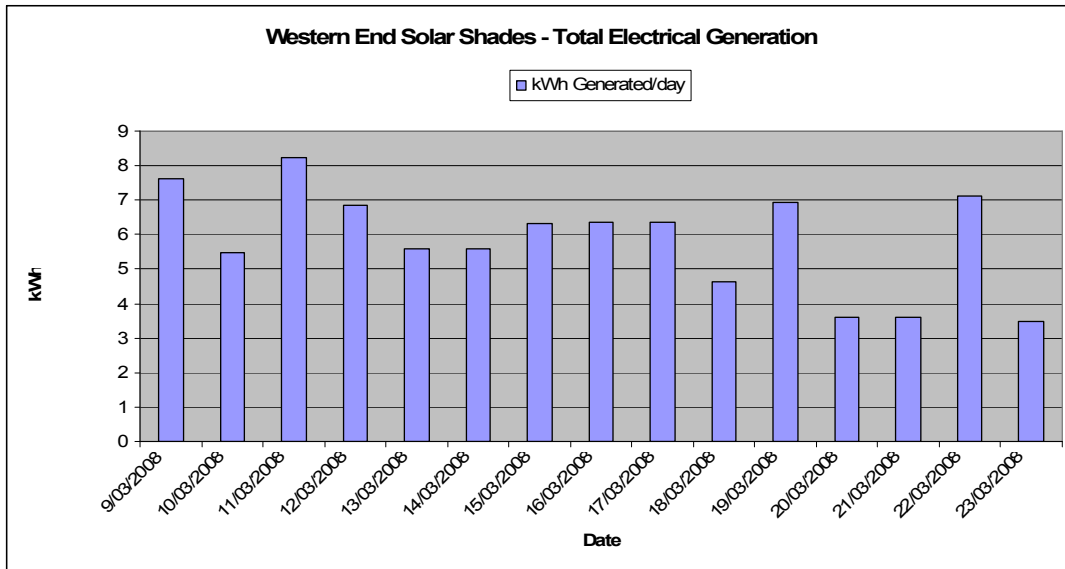
Graph 5.2: Polycrystalline PV Solar Shades – Western End

This array appears to be operating quite well, however this generation data is only depicting the summer performance of the system. It would be expected that the winter electrical generation of this system would be quite low due to its west facing orientation. In winter, the reduced number of sunlight hours will result in far less solar radiation actually striking this array, and thus reducing the expected electrical output of the system.

As mentioned previously however, electrical generation performance was not the only criteria with this installation, providing shading of the 4th floor west facing windows was also a major concern. Therefore, the installation of this array has resulted in the addressing of the shading issue as intended, as well as providing some extra renewable energy generation capacity to the building.

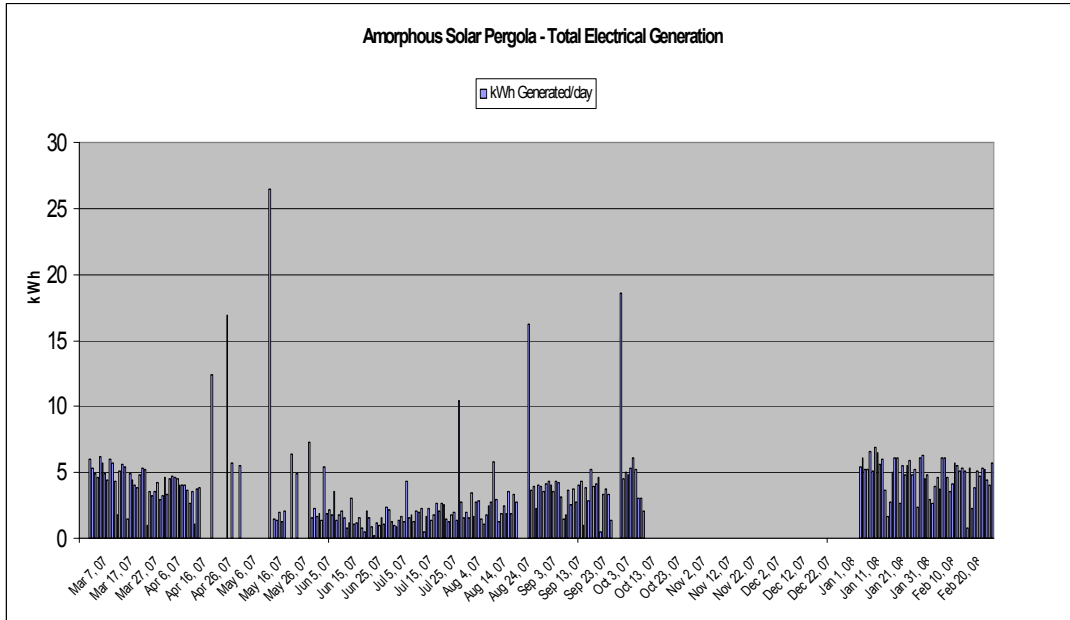
Graph 5.3: Amorphous PV Electrical Energy Generation

As can be seen from figure 5.4 above, the Amorphous PV array was not generating any power over the period from October 14 2007, through to January 7 2008 – a total of 86 days. This was due to water ingress of the exposed conduit work, DC isolator, and inverter cubicle of this system. This water damage caused the DC isolating switch to open circuit, and thus not allow any power generated by the array to flow through to the inverter. This problem has now been fixed, as it can be seen that power is now being generated by the system from January 7 onwards.

Taking this breakdown into account, the average daily generation of this system would then actually be greater than the predicted value. That is, if we include the power generated by the system over the same time period the previous year, then the total electrical energy generated over the analysis period is 1.35 MWh.

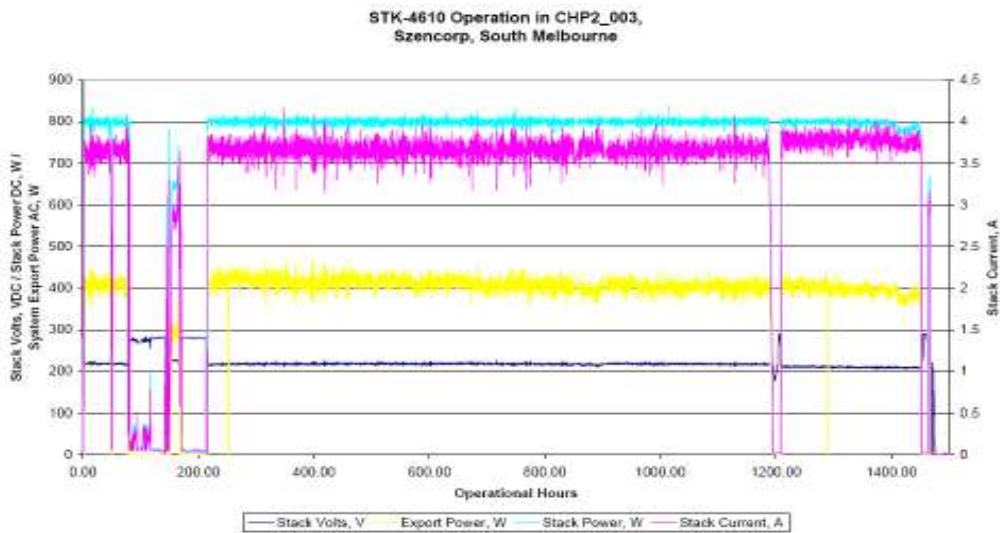
Graph 5.4: Ceramic Fuel Cell – Stack 4610 Operation

Stack number 4610 was installed 12th February 2007 and was shut down on 17th April 2007. As can be seen, a constant 400W of export power was sent to the grid over this period of operation.

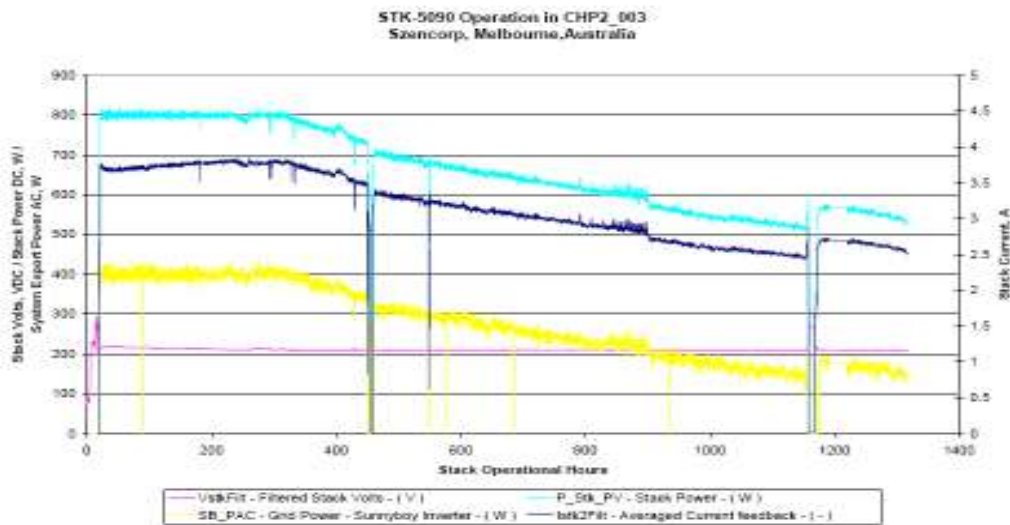
Graph 5.5: Ceramic Fuel Cell – Stack 5090 Operation

Stack number 5090 was installed on 12th June 2007 and was shut down on the 8th August 2007. As can be seen this stack started at an export power of 400 Watts, which over the trial period slowly reduced to an end export value of just under 200 watts. The system has been in hibernation since the 8th August 2007, and thus is currently producing no electrical energy, or thermal heat energy for hot water.

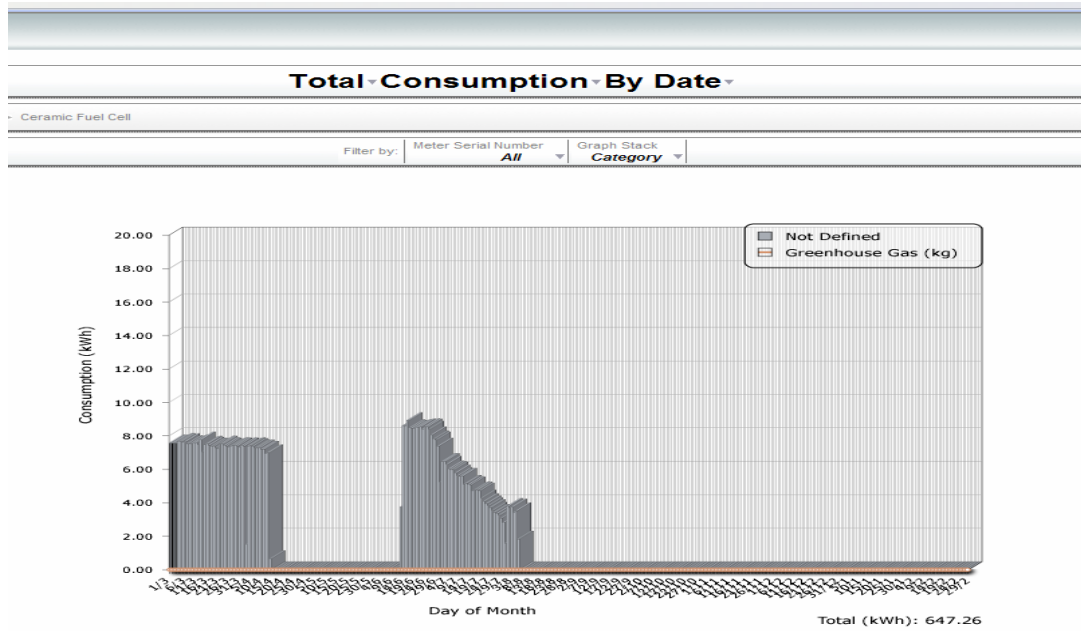
Image 5.2: Ceramic Fuel Total Electrical Generation 1/3/2007 to 1/3/2008

From image 5.2 above, the two definite generation periods for the two different stack configurations can be easily seen. Cell stack 4610 generated a fairly constant output of approximately 7.5 kWh per day over its operational period. Cell stack 5090 started generating at a slightly higher output value, and then slowly tapered off the amount of daily electrical generation until it was finally shut down.

The total electrical generation of the fuel cell unit for the period 1st March through to 1st March 2008 is **647.26 kWh**.

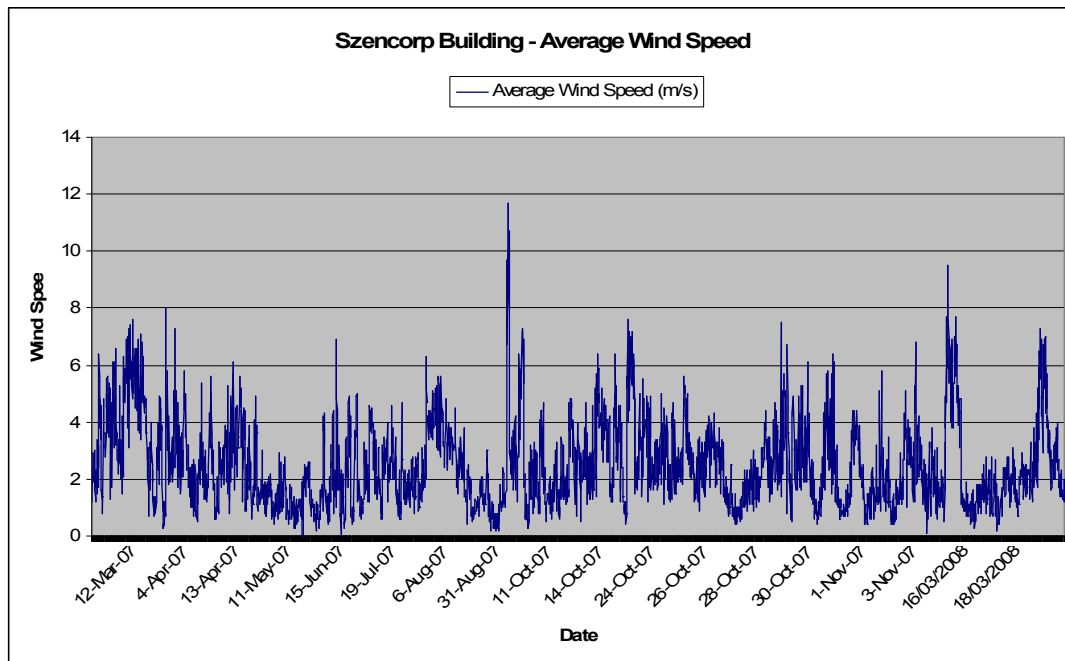
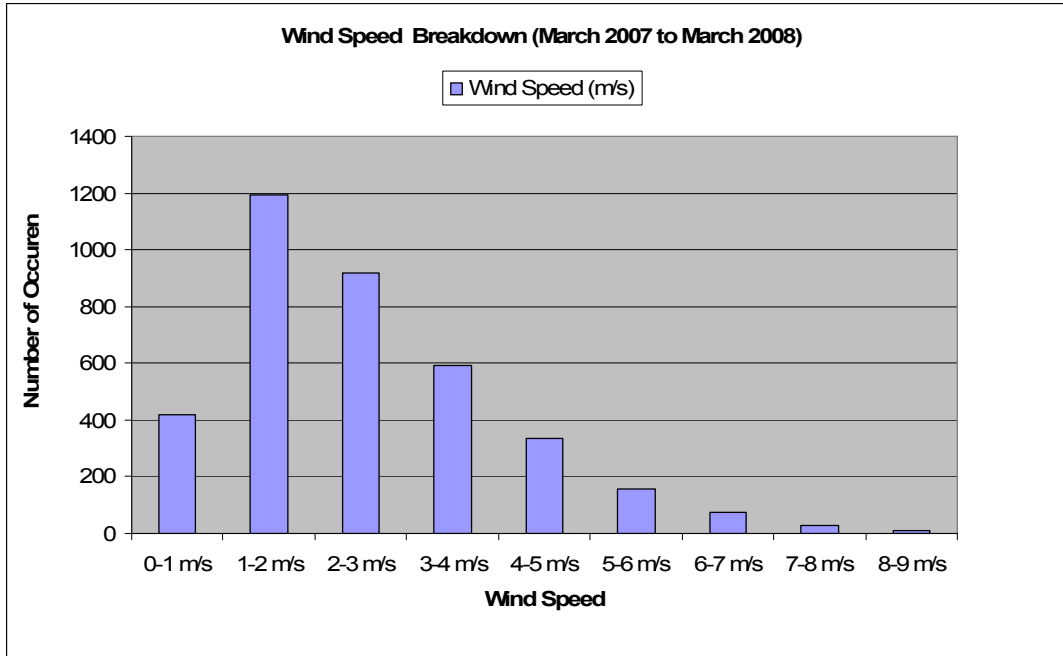
Average wind speed over 1 yr period: 2.5 m/s
 Highest recorded wind speed over 1 yr period: 11.7 m/s
 Percentage of time wind speed > 5m/s: 7.1 %

As can be seen from the two figures above, the average wind speeds present at the Szencorp building site are quite low. The normal cut-in wind speed required for a wind turbine to start generating any useful power is at least 5 m/s. Over the 1 year recording period, the proportion of time that the wind speed was high enough for a wind turbine to produce any power at all was only 7.1%.

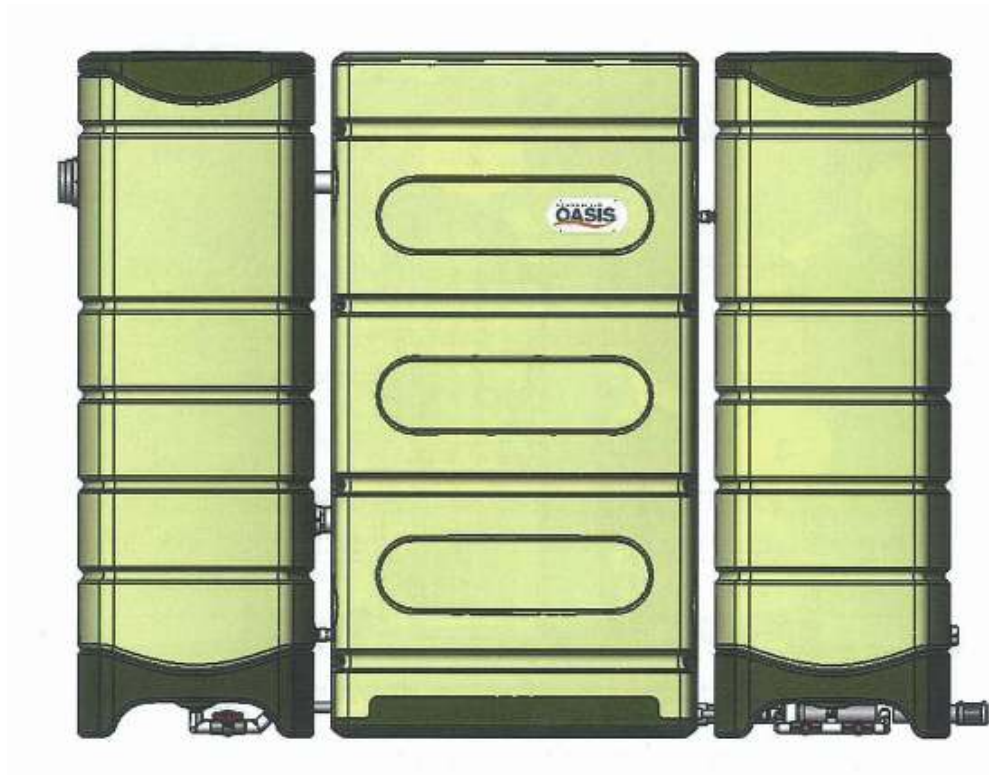
Figure 7.1 Oasis GT600 by Nubian Water Systems

The recovered water output of the unit as a percentage of water recycled from the building is unknown. In order to determine this performance a meter installation is required in the delivery pipe work to the Nubian system, the performance of the system can then be determined by difference with the existing recovered water meter.

The general performance of the Nubian has been very good, with greater reliability and lower fouling than the previous grey water installation. The system has been put through its paces though with tenancy fit out workers on level 1 washing down plaster into the recycled water system, turning the water murky and grey. There is currently an investigation taking place to determine if the unit was damaged in the process. Now that the new pipe work and connections are made it is recommended that metering for this and the rain water collection systems are reinstated to the BMS and that the naming of these meters reflect their new location within the system.

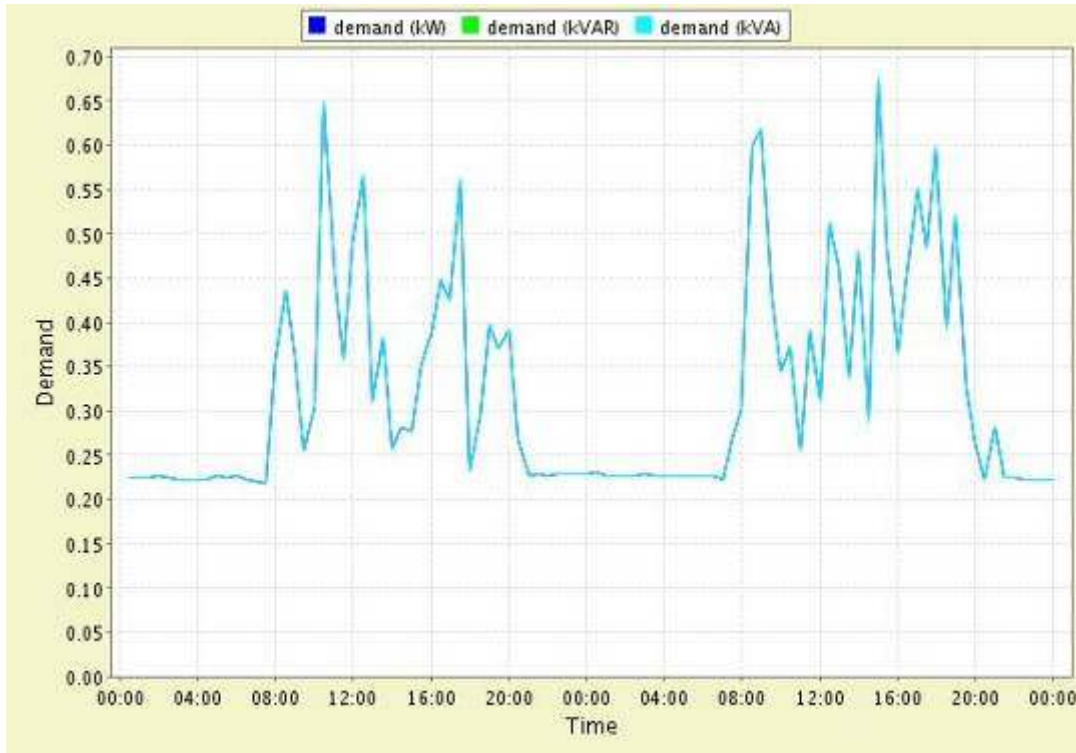
Graph 8.1: Lift energy demand during first year operation

The graph 8.1 indicates a base load of approximately 225 Watts, which was attributed mainly to the lighting in the lift, which remained on all the time.
